Tarpon Landing Condominium Association, Inc.

**Structural Integrity Reserve Study**

For Period Beginning January 1, 2026

6021, 6061, & 6081 Silver King Boulevard, Cape Coral, FL, 33914

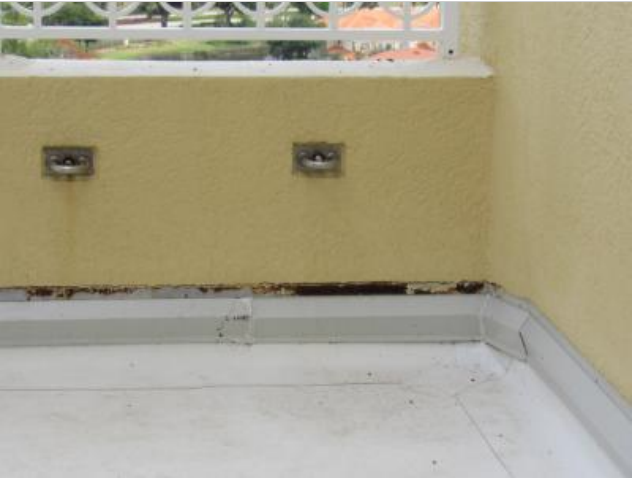
Cracked stucco and staining at the counter flashing.

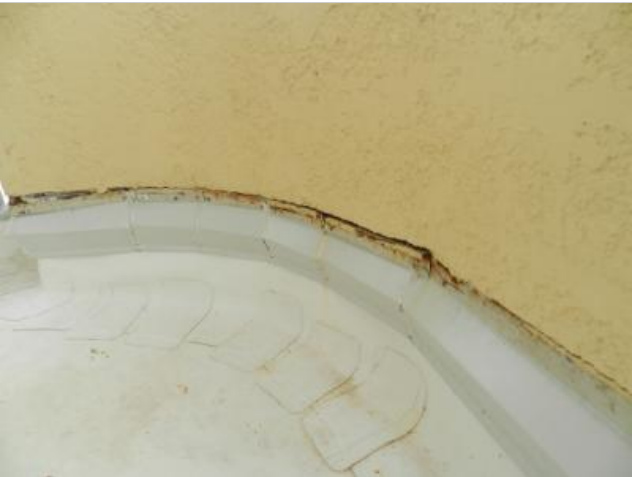
Cracked stucco and rust at the counter flashing.

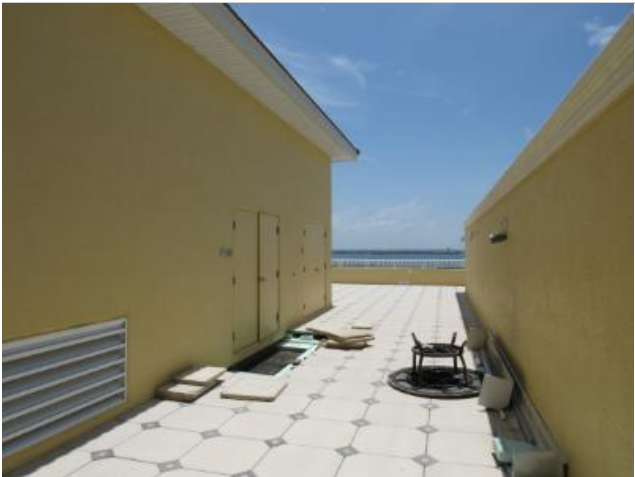
Private Roof Terrace - Ongoing repair to the pedestal paver system

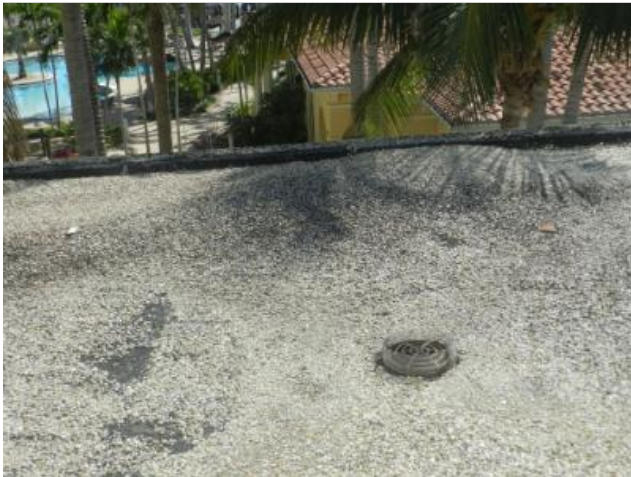
The cabana units and sections of the parking garage are covered with a flat, built-up gravel ballast roof system that we understand is original. We further understand that the Florida Building Code no longer permits this type of roof system and that when this roof area requires replacement, the Association will plan to replace it with a TPO roof system. This roof system appears to be in fair to poor overall condition, considering its age, areas of previously reported repairs, and areas of current ongoing repairs. Also, a few areas appeared to be lacking gravel, exposing the roof system below. This type of roof system typically has a useful life of 20 to 25 years or more, depending on the level of maintenance, such as completing annual maintenance/preventative inspections and applying more gravel and roof binder as needed. We understand that the Association hired Roof Leak Detection Company, Inc., which completed a roof evaluation and moisture survey of these roof areas circa 2023, and provided an approximate remaining life of 5+ years. Based on their moisture survey and request of the Association's representative, we have included a budget based on these roofs being replaced five years after the completion of their roof moisture survey, in 2028. Please be advised that any additional ongoing leaks should be repaired as needed to prevent water intrusion, and at this point, any repairs should be considered temporary until these roof systems are replaced.

Typical gravel ballast roof. Note area of missing gravel coverage.

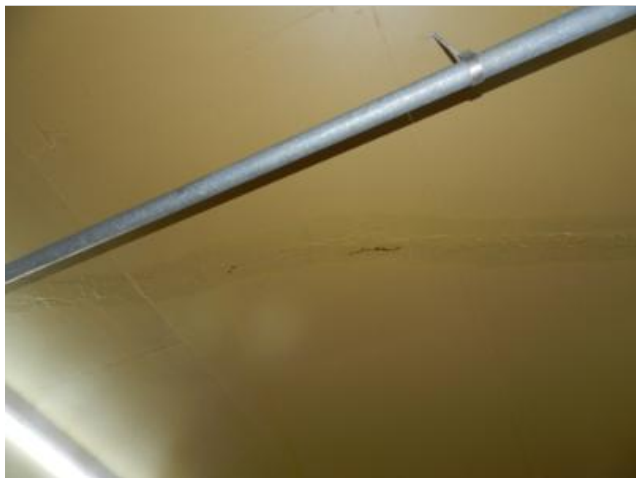
Parking Garage ceiling - Staining and potential signs of water intrusion at a location that was previously repaired.

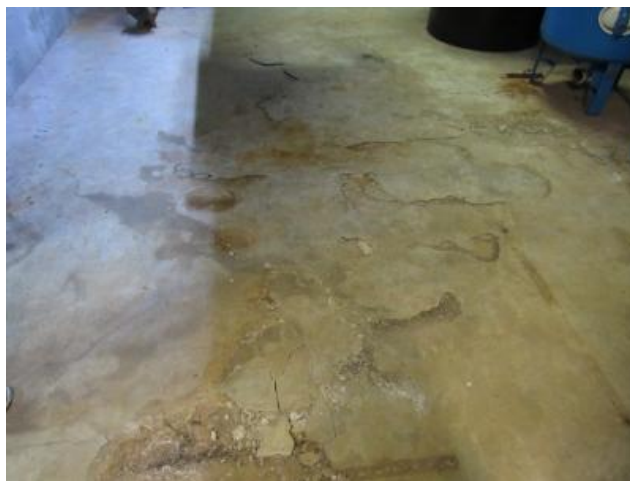
Concrete slab on grade cracks and spalling at the domestic water pump room.

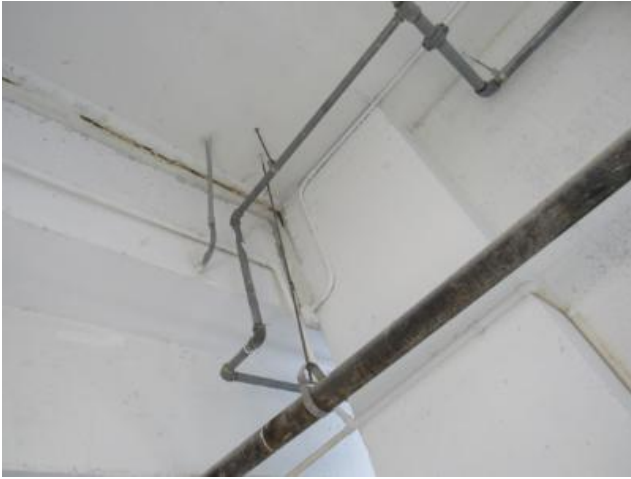
We understand that during the previous exterior painting and restoration project, structural modifications within the fountain equipment rooms were completed, and an expansion joint was installed between the fountain equipment rooms and main towers at each building except for this Building, 6021. We understand that a portion of the fountain equipment room is on a separate foundation and not tied into the deep pile foundations on which the main structures are supported. We further understand that this differential movement between the two structures caused cracking and water intrusion at the joint between the structures. After the expansion joints were installed, it was sealed from the exterior side, and the Association elected not to complete what we understand would have been cosmetic repairs from the interior side. It was reported by the Association's representative that they are continuing

Expansion joint deterioration observed from within the fountain equipment room.

to monitor the previous repairs at the other buildings and will plan to add an expansion joint at this building as needed in the future. Additional funding has been allocated to the exterior painting and restoration budgets to help monitor these areas and maintain the joints and seals between these structures. Any concrete restoration needed would fall under this concrete frame repair budget.

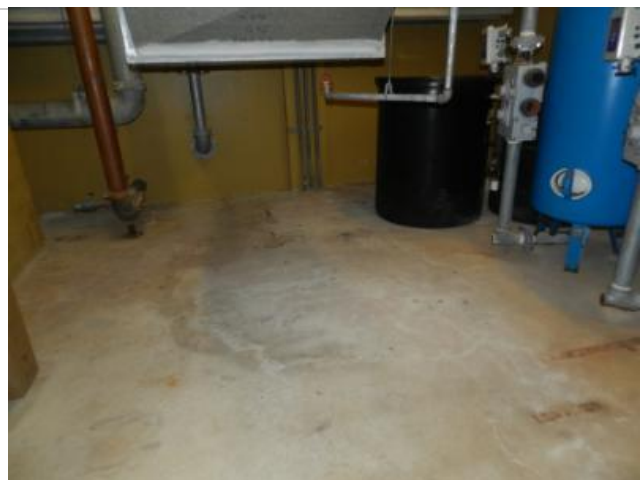
Concrete slab cracks in domestic water pump room.

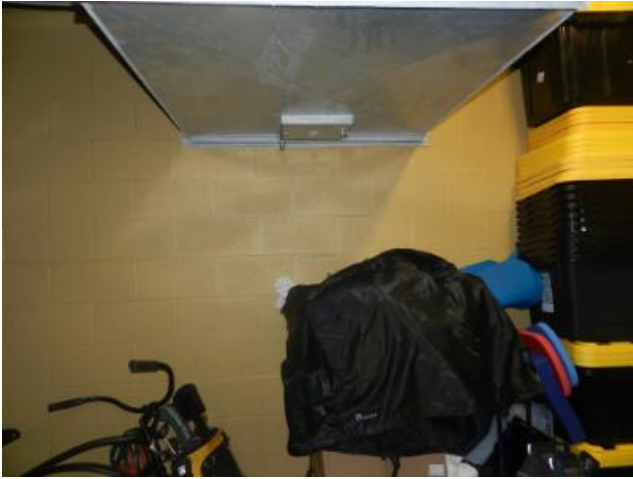
CMU-step-cracking within Private Garage #10.

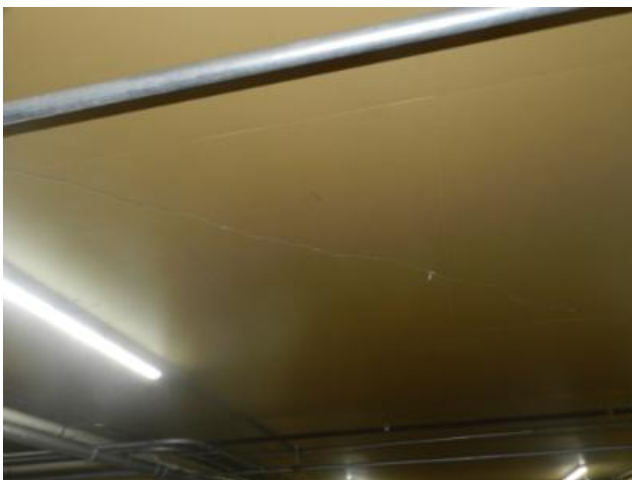
Parking garage ceiling crack.

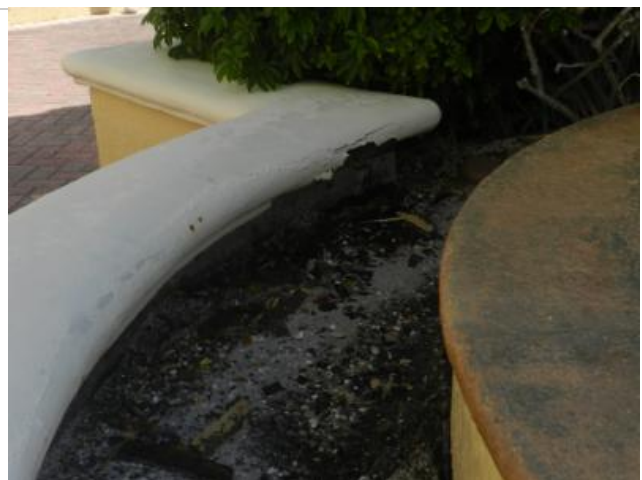
Damaged planter wall cap.

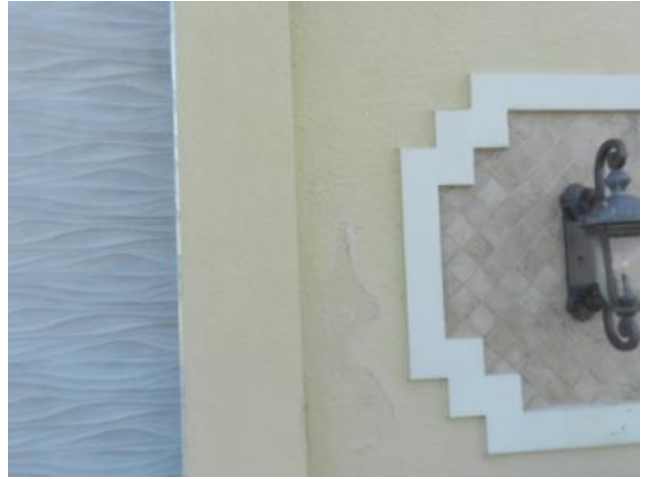
Crack on wall of main entry ramp.

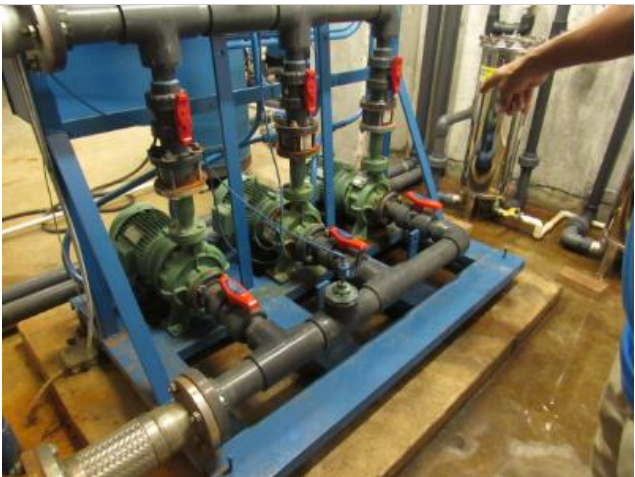
Standing water was noted adjacent to the pump equipment, and it appeared that one of the pump connections was leaking. Considering the apparent leak, this system appeared to be in fair overall condition.

Standing water and apparent leak.

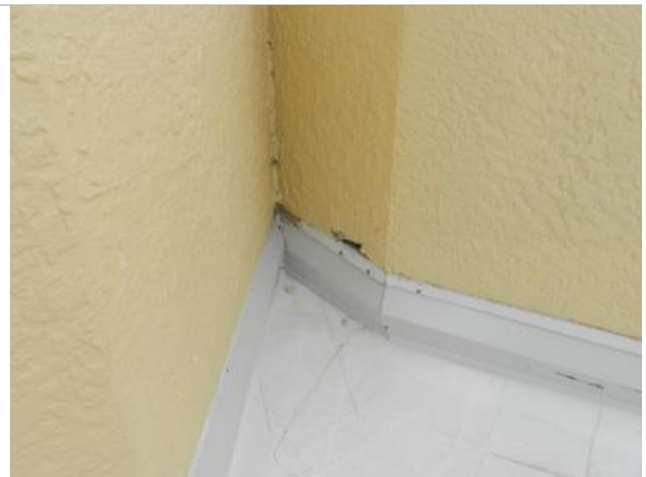
Crack in stucco above counterflashing.

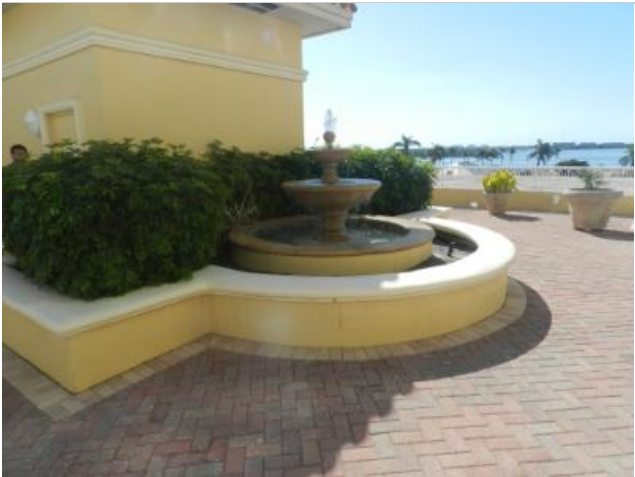
Elevated planters above parking garage. Staining and cracked planter wall cap.

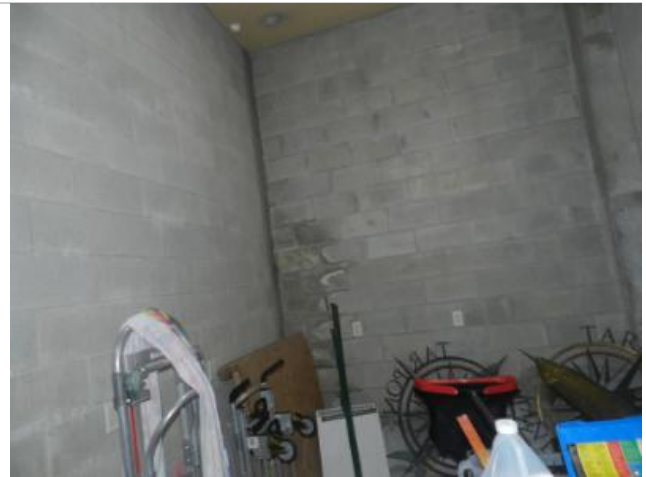
Signs of water intrusion into private garage #59

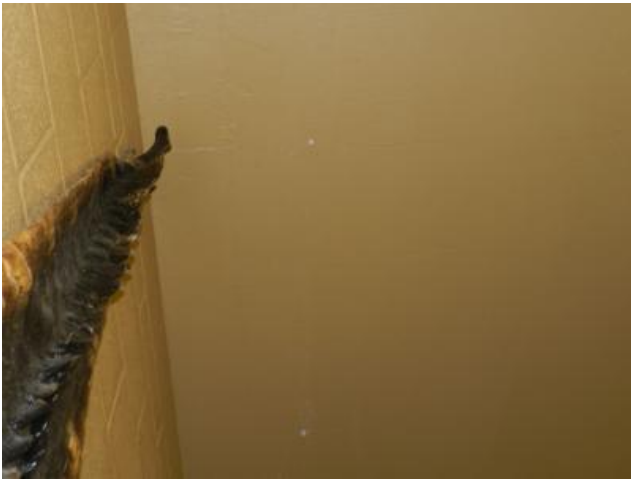
Signs of water intrusion into private garage #56

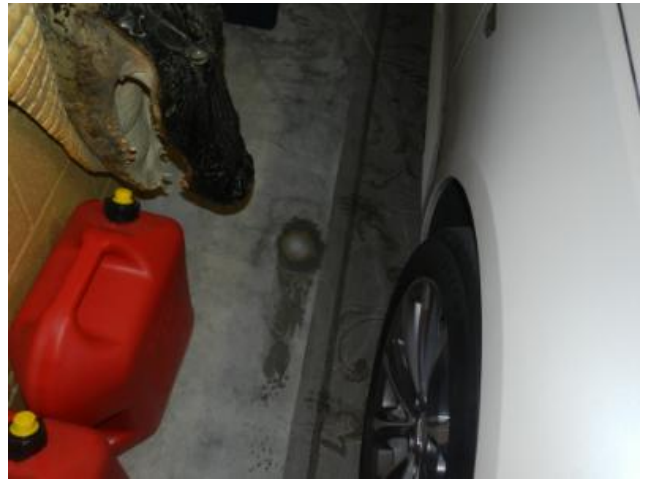
Signs of water intrusion into private garage #56

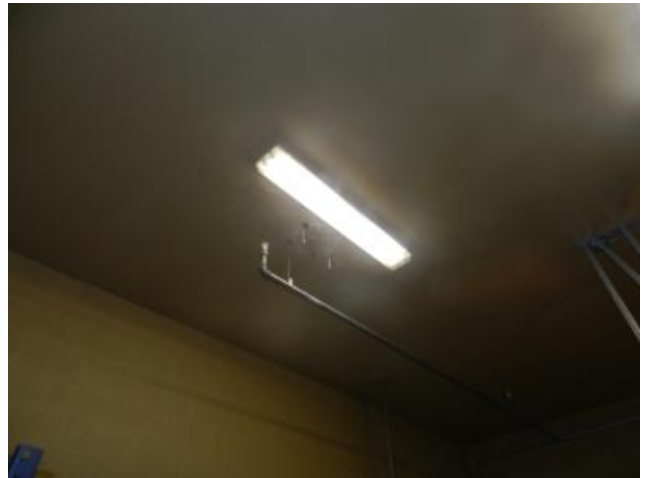
Signs of water intrusion into private garage #55

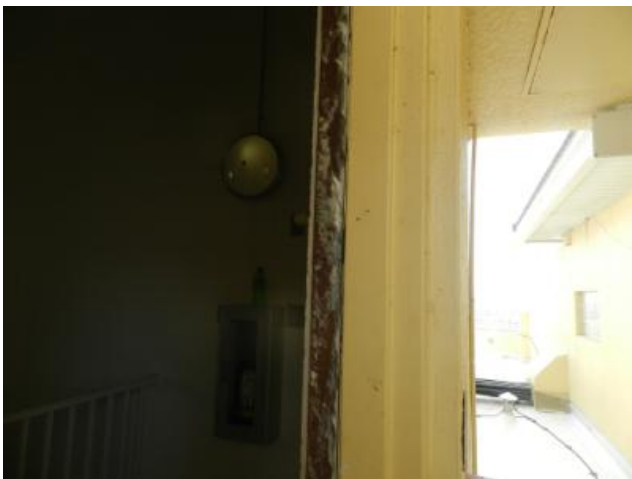
Minor door frame corrosion. Signs of previous maintenance and removal of corrosion.

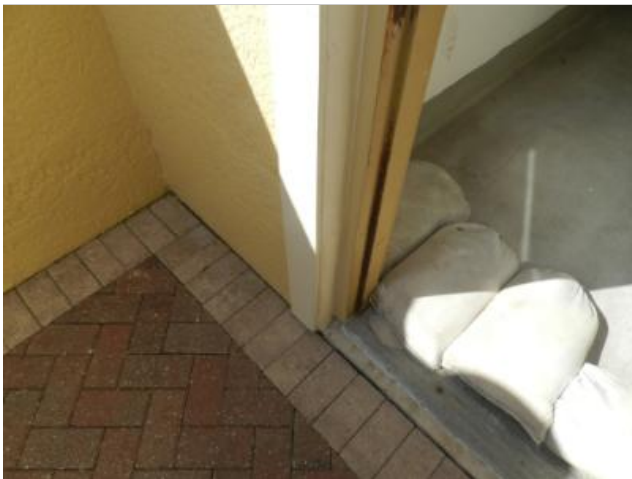
Minor door frame corrosion. Ponding water/water intrusion reported at garage deck entry door. Sandbags are reportedly utilized to help prevent water intrusion.
