Tarpon Landing Condominium Association, Inc.

**Structural Integrity Reserve Study**

For Period Beginning January 1, 2026

6021, 6061, & 6081 Silver King Boulevard, Cape Coral, FL, 33914

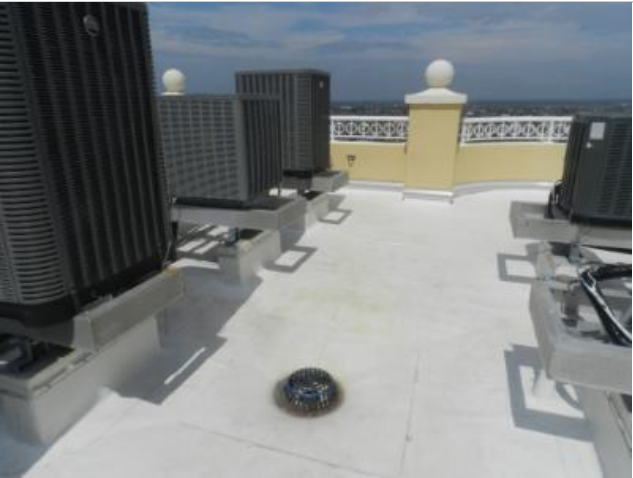
The flat roof service areas located on the main roofs include thermoplastic polyolefin (TPO) roof systems that we understand were recently replaced in 2024. This type of roof system typically has a useful life of 20 to 25 years under normal operating conditions with routine yearly maintenance. At the time of our site visit, these roof systems were observed to be in good overall condition. However, cracked stucco and rust was noted at the counter-flashing to stucco intersection. These areas should be repaired as needed to prevent potential water intrusion from behind the counter-flashing. We have included a reserve item for the replacement of these roof systems based on an approximate 20-year useful life.

Typical TPO roof covering system and HVAC stands.

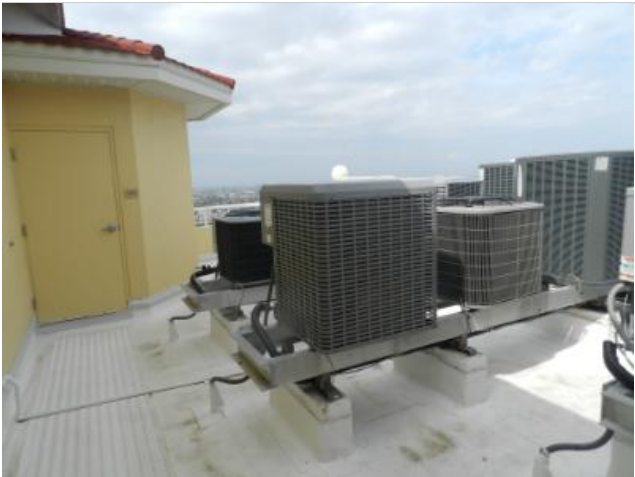
Typical TPO roof covering system, HVAC stands, roof access door, and stone-coated metal panels.

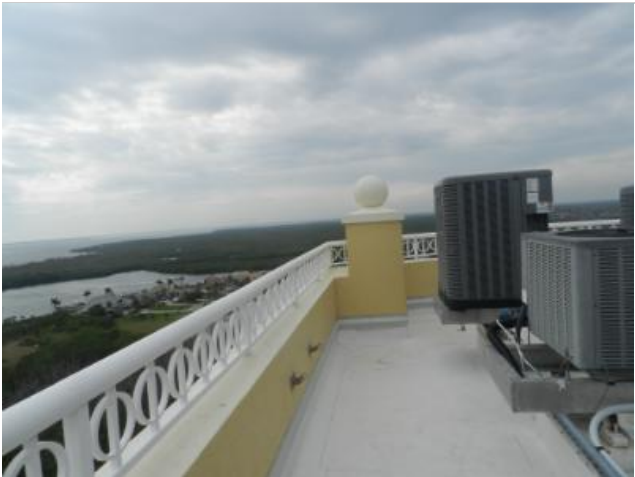
# 03 - 6081 Tower - Flat, TPO

Typical TPO roof covering system, HVAC stands, and fall protection anchors.

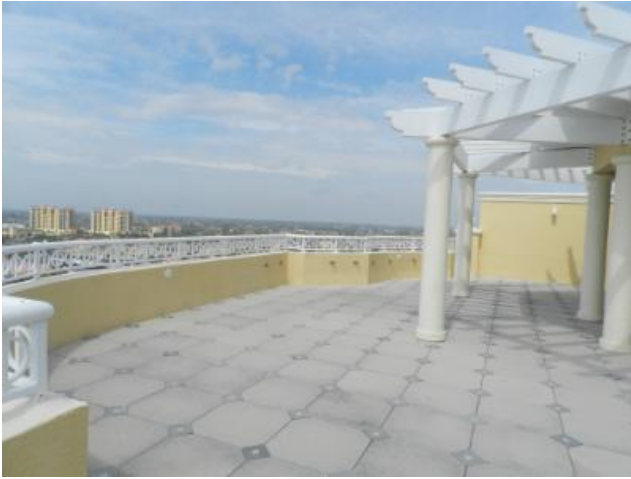
The roofing system over the private penthouse terraces includes a pedestal paver system over a modified bitumen (Mod. Bit.) roofing system. We understand that the unit owners are responsible for the pedestal paver system, and the Association is responsible for the underlying modified bitumen membrane. We further understand that this roof system is original and appears to be in good to fair overall condition, considering its age. Mod. Bit. roof systems typically have a useful life of 20 to 25 years under normal operating conditions with routine yearly maintenance. However, Mod. Bit. systems installed below a pedestal paver system typically achieve an extended useful life of 30 to 40 years, considering the reduced exposure to the elements and UV light. A reserve budget based on an extended useful life of 30 years has been included for the underlying Mod. Bit. system.

Private Roof Rerrace - Pedestal paver roof system  
(mod. bit. below pedestal pavers).

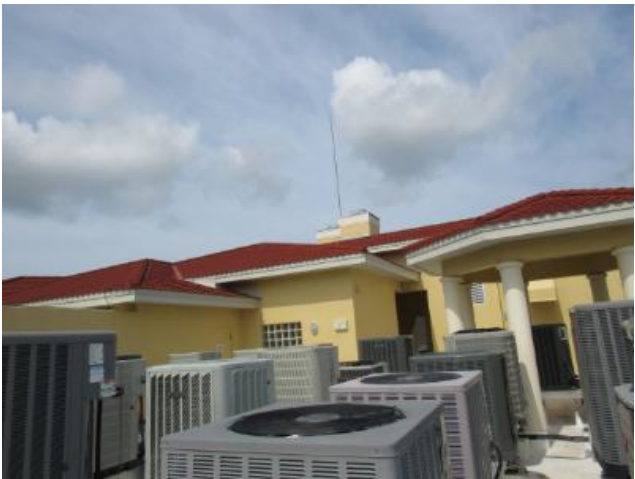
# 07 - 6021 Tower - Stone-coated Metal Panels

Sections of the main towers over the staircases, penthouses, and mechanical rooms include sloped stone-coated metal panel systems. This type of roof system typically has a useful life of 30 to 40 years under normal operating conditions with routine yearly maintenance. We understand that this system is original and appears to be in good to fair overall condition considering its age. A reserve budget for the replacement of this roof system has been included based on a 40-year useful life.

Typical sloped stone-coated metal panels.

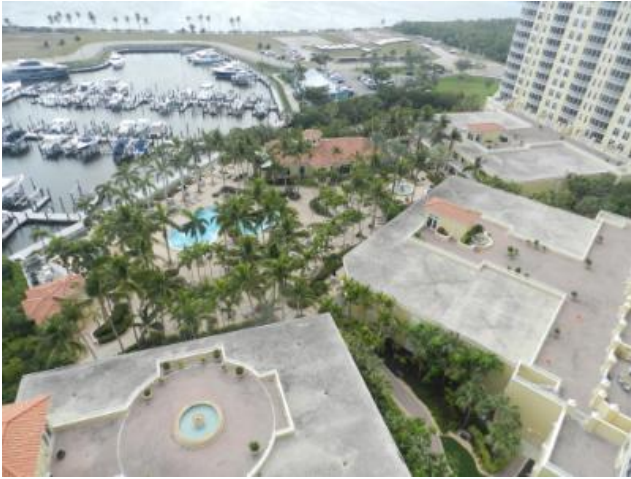
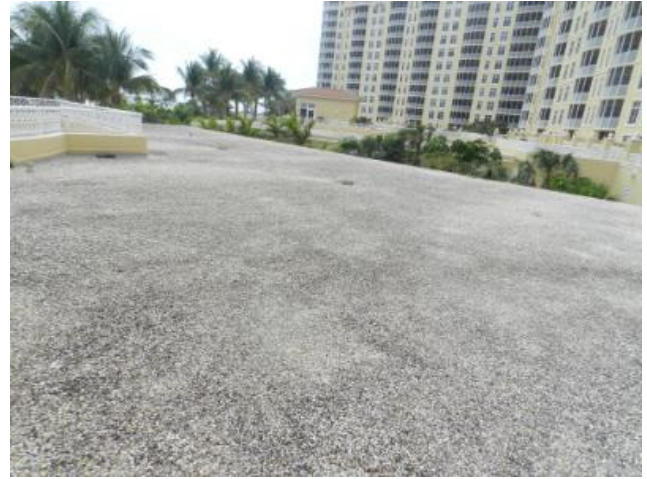
# 10 - 6021 Cabana - Gravel Ballast (Replace w/ TPO)

The cabana units and sections of the parking garage are covered with a flat, built-up gravel ballast roof system that we understand is original. We further understand that the Florida Building Code no longer permits this type of roof system and that when this roof area requires replacement, the Association will plan to replace it with a TPO roof system. This roof system appears to be in fair to poor overall condition, considering its age, areas of previously reported repairs, and areas of current ongoing repairs. Also, a few areas appeared to be lacking gravel, exposing the roof system below. This type of roof system typically has a useful life of 20 to 25 years or more, depending on the level of maintenance, such as completing annual maintenance/preventative inspections and applying more gravel and roof binder as needed. We understand that the Association hired Roof Leak Detection Company, Inc., which completed a roof evaluation and moisture survey of these roof areas circa 2023, and provided an approximate remaining life of 5+ years. Based on their moisture survey and request of the Association's representative, we have included a budget based on these roofs being replaced five years after the completion of their roof moisture survey, in 2028. Please be advised that any additional ongoing leaks should be repaired as needed to prevent water intrusion, and at this point, any repairs should be considered temporary until these roof systems are replaced.

Overall view of the gravel ballast roofs and interlocking concrete paver decks.

Typical gravel ballast roof.

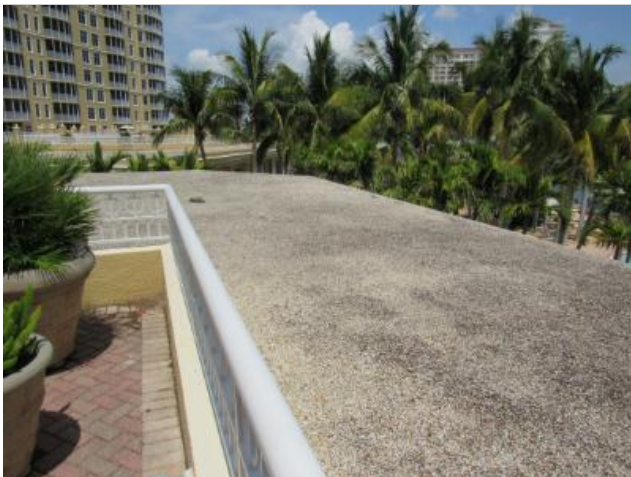
# 11 - 6061 Cabana - Gravel Ballast (Replace w/ TPO)

Typical gravel ballast roof and adjacent interlocking concrete paver deck.

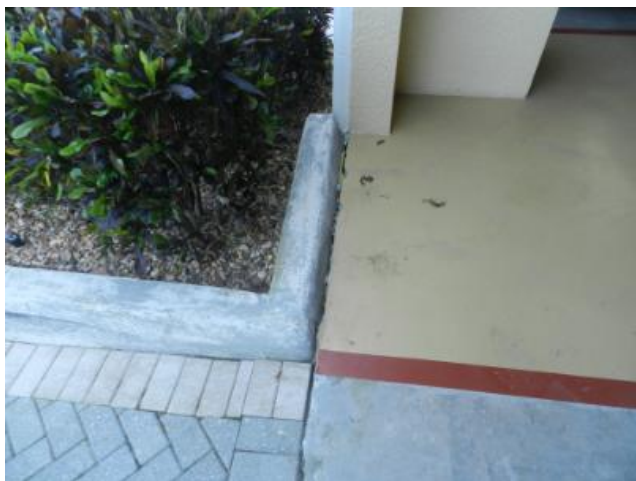
We understand that during the previous exterior painting and restoration project, structural modifications within the fountain equipment rooms were completed, and an expansion joint was installed between the fountain equipment rooms and main towers at each building except for this Building, 6021. We understand that a portion of the fountain equipment room is on a separate foundation and not tied into the deep pile foundations on which the main structures are supported. We further understand that this differential movement between the two structures caused cracking and water intrusion at the joint between the structures. After the expansion joints were installed, it was sealed from the exterior side, and the Association elected not to complete what we understand would have been cosmetic repairs from the interior side. It was reported by the Association's representative that they are continuing

Expansion joint between garage ramp curb and building slab.

to monitor the previous repairs at the other buildings and will plan to add an expansion joint at this building as needed in the future. Additional funding has been allocated to the exterior painting and restoration budgets to help monitor these areas and maintain the joints and seals between these structures. Any concrete restoration needed would fall under this concrete frame repair budget.

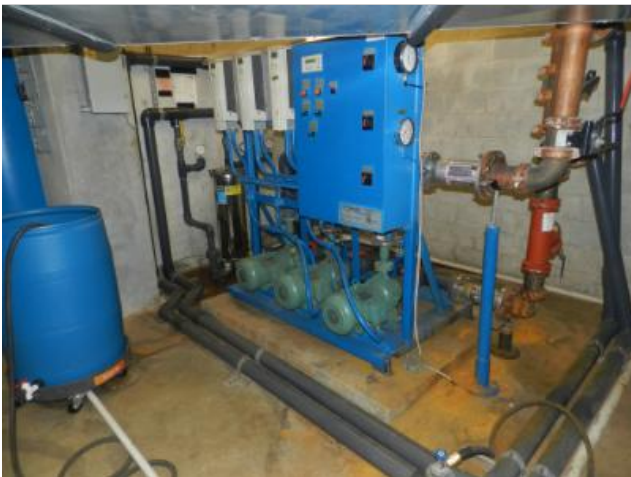
Standing water was noted adjacent to the pump equipment, and it appeared that one of the pump connections was leaking. Considering the apparent leak, this system appeared to be in fair overall condition.

Typical variable speed domestic water pump system.

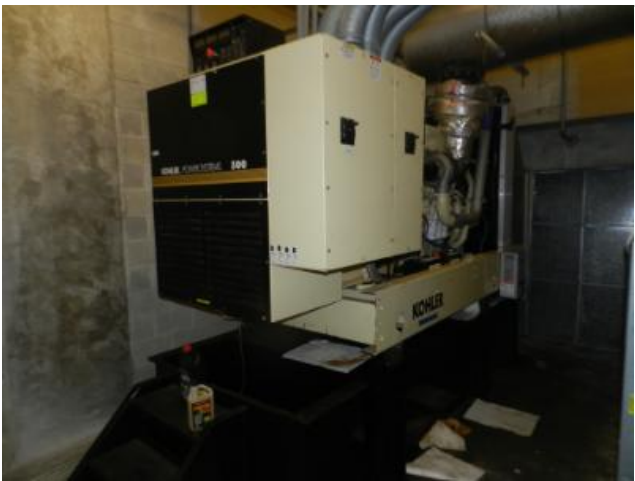
# 28 - 6021 Generator & Transfer Switch

The building is provided with a 475 kW Kohler diesel-powered generator. The generator, pad, fuel tank, and transfer switch are original components and appear to be in good overall condition. Typically, diesel generators and related equipment have a useful life of approximately 30 to 40 years and can be repaired or rebuilt as needed, depending on the availability of the parts needed for repair/replacement. An approximate replacement cost for these systems has been included based on a 30-year useful life. It was reported by the Association representative that the main engine and other components on the generator were rebuilt and replaced. Therefore, we have reset the useful life of this generator.

Typical emergency diesel generator.

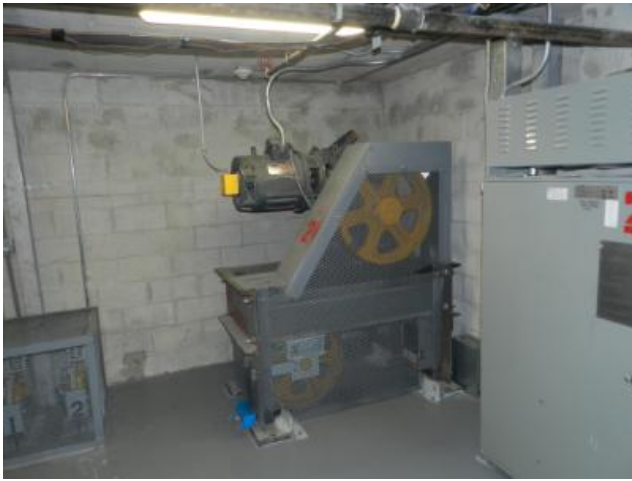
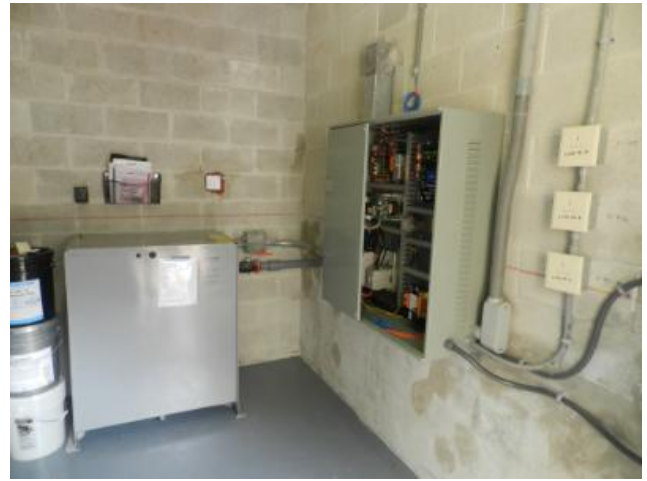
Main traction elevator equipment and controls.

Hydraulic elevator controls and pump housing container.

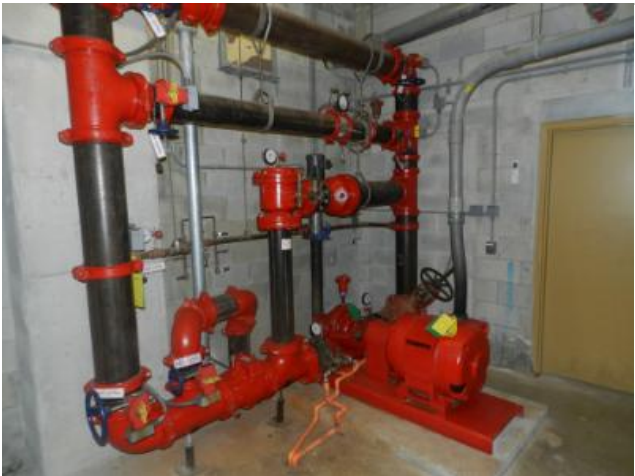
It was reported that this main pump was rebuilt circa 2024. It was further reported that due to an electrical issue with these components the motor and main controller reportedly failed and were replaced this year, 2025. Based on this information, we have scheduled the next replacement for 2059 based on a typical useful life of 35 years.

Typical emergency fire pump.

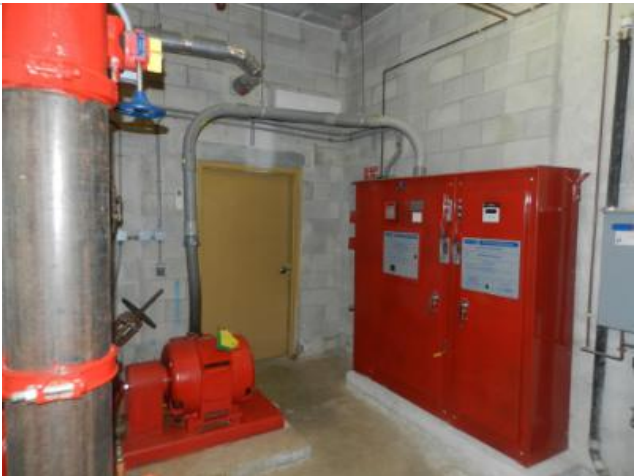
Fire pump main controls.

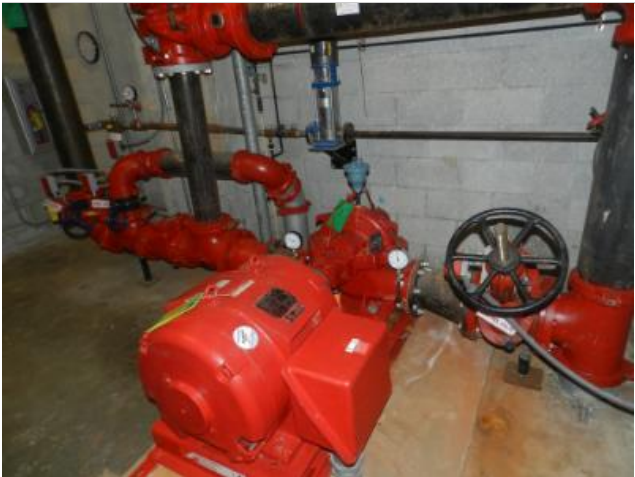
We understand that 6024's pump was replaced in 2024. However, we have scheduled this system for replacement based on its original useful life, considering the other main components are original.

Typical emergency fire pump.

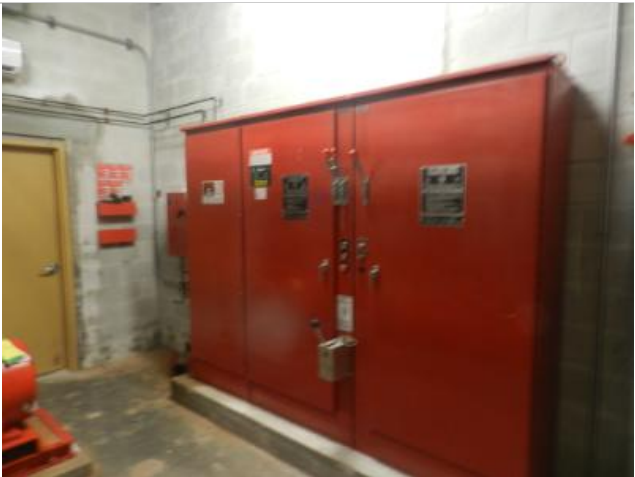
Fire pump main controls.

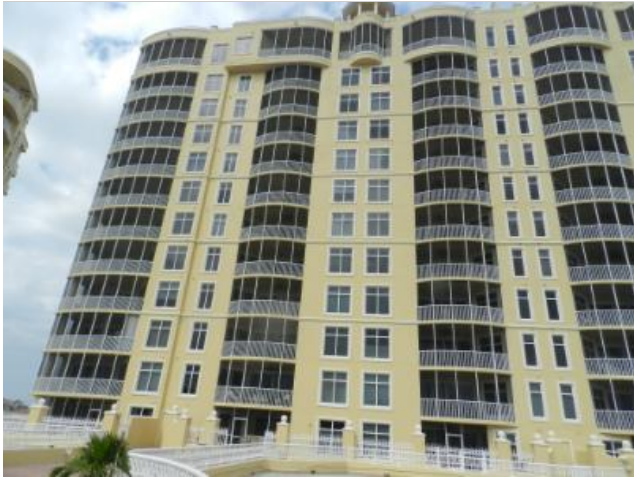
We understand that during the previous exterior painting and restoration project, structural modifications within the fountain equipment rooms were completed, and an expansion joint was installed between the fountain equipment rooms, which we understand is on a separate foundation and not tied into the deep pile foundations on which the main structures are supported. We further understand that this differential movement between the two structures caused cracking and water intrusion at the

joint between the structures. Furthermore, after the expansion joint was installed, it was sealed from the exterior side, and the Association elected not to complete what we understand would have been cosmetic repairs from the interior side. This budget also includes funding to help monitor this area and maintain the joint and seal between these structures. Any concrete restoration needed would fall under the concrete frame repair line item.

Exterior of Building 6021.

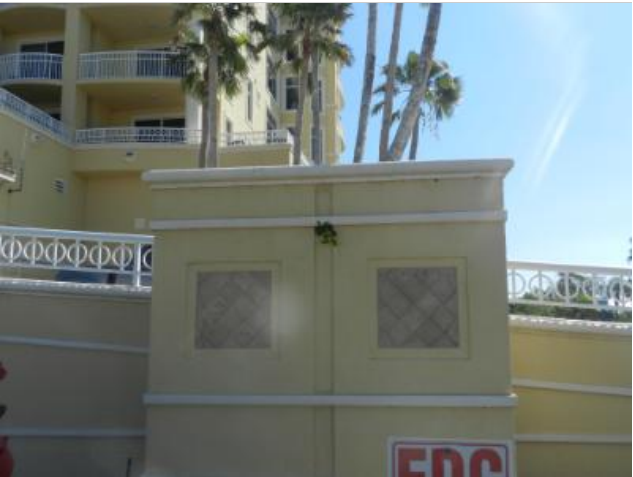
Vegetative growth into stucco.

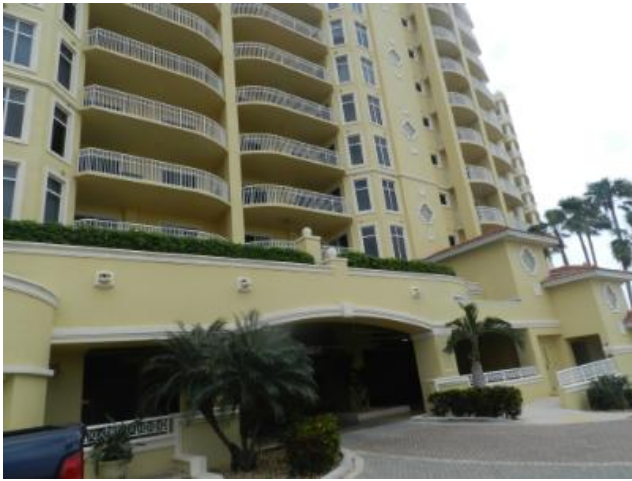
Elevated planters above garage entry.

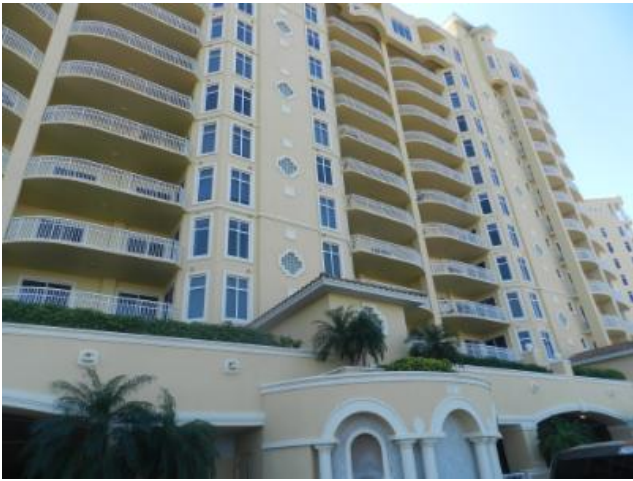
Elevated planters above garage entry.

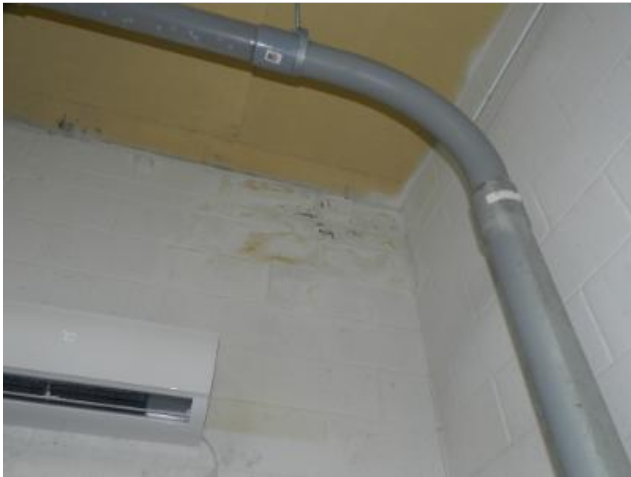
Signs of water intrusion in the fire pump equipment room.

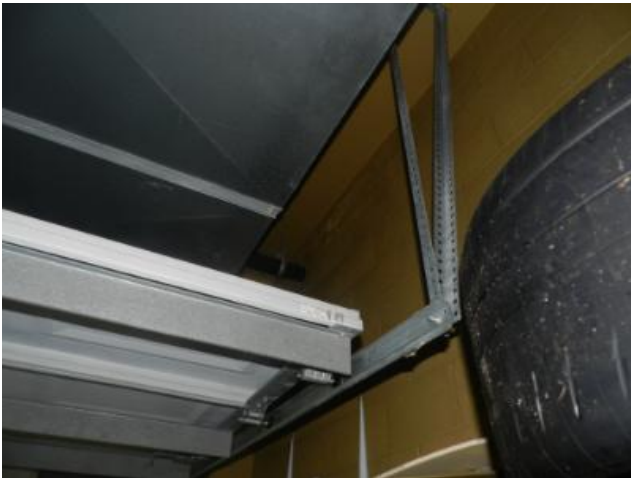
Signs of water intrusion into private garage #57

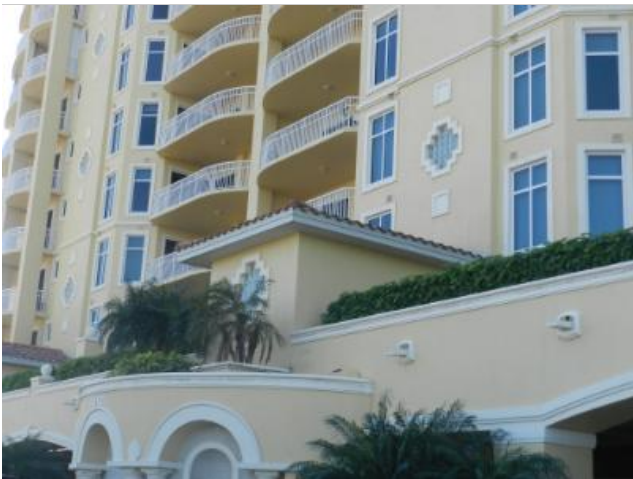
Typical exterior glass block openings.

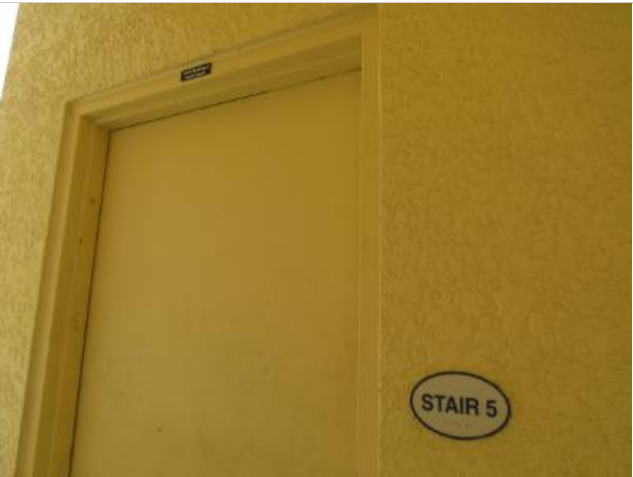
Typical exterior metal door.
